Roof Report prepared for:
Regency Centers

**Paces Ferry Plaza
3539 Northside Pkwy, Atlanta GA**

January 14, 2016

Roof Inspection

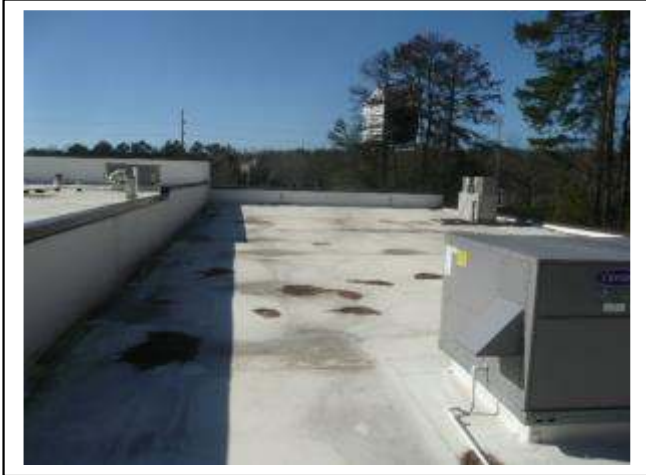
The TPO roofs are in very good condition. No major problems were observed. With routine maintenance, repairs, and cleanings, the roof should provide many more years of useful service life. There was a moderate accumulation of organic debris (pine straw) on 2 & 3 despite it having been cleaned about a month ago which indicates that it may need to be cleaned more often. Removing the trees along the left side of the building would be a big help in keeping the roofs free of debris. The following anomalies exist:

Overview of TPO roof **suites 2,3**

- Estimated cost for the following 4 items: \$1,250
- Clean debris from roofs and gutters
- Aluminum coat rusty vent pipes, gas lines, hoods, and external HVAC duct work
- Seal all gutter joints, outlets, and end caps
- Inspect all coping metal joints and seal as needed

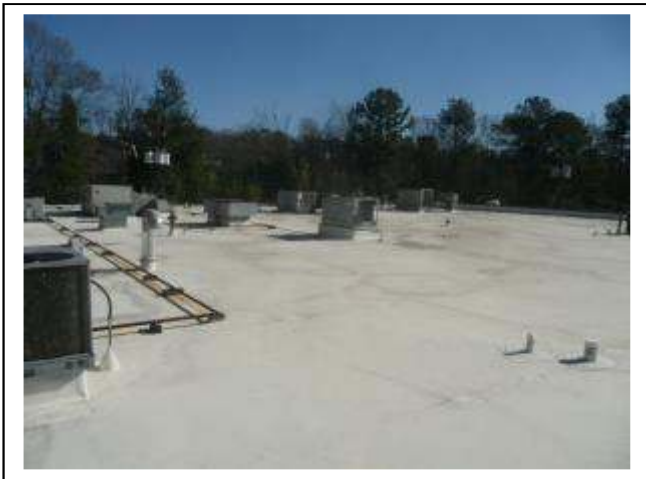
Overview of TPO roof **suites 4,7,8**

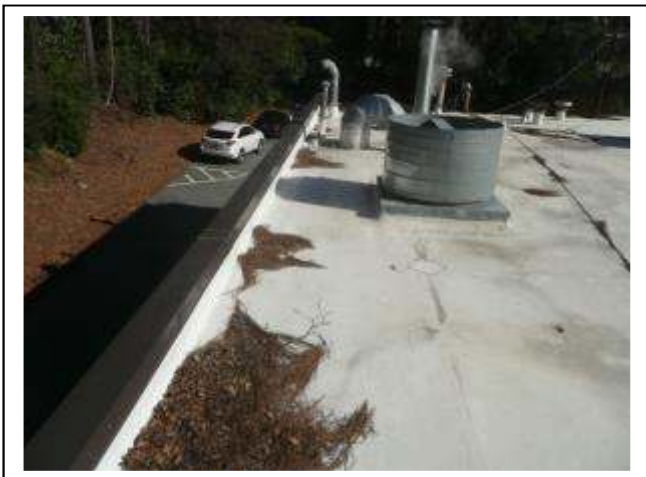
Debris on the roof- mostly pine straw

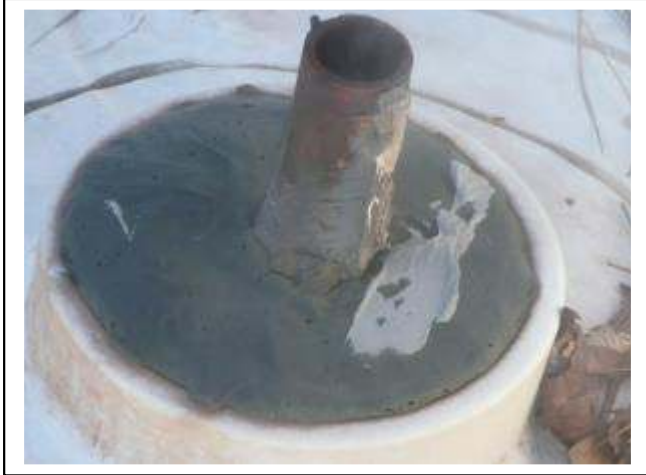
Open pitch pan

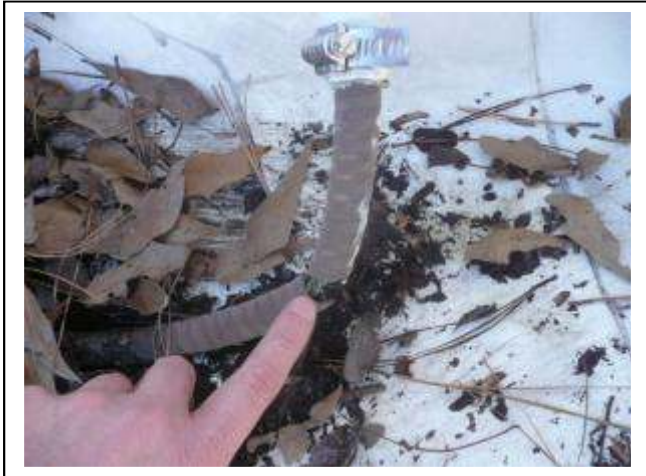
Broken/open electrical conduit

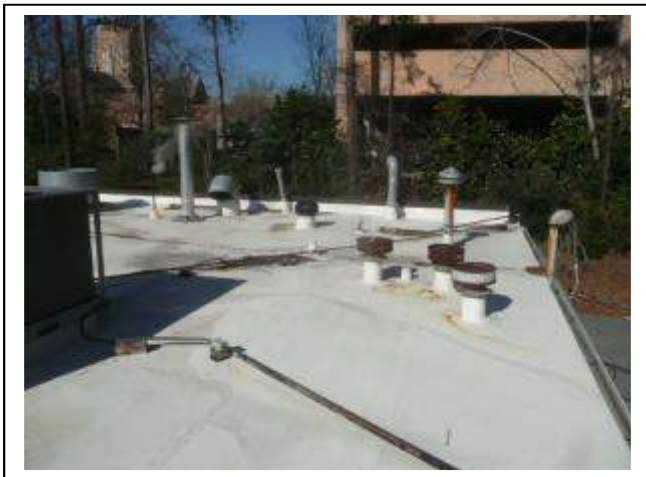
Lots of penetrations for the cleaners
tenant

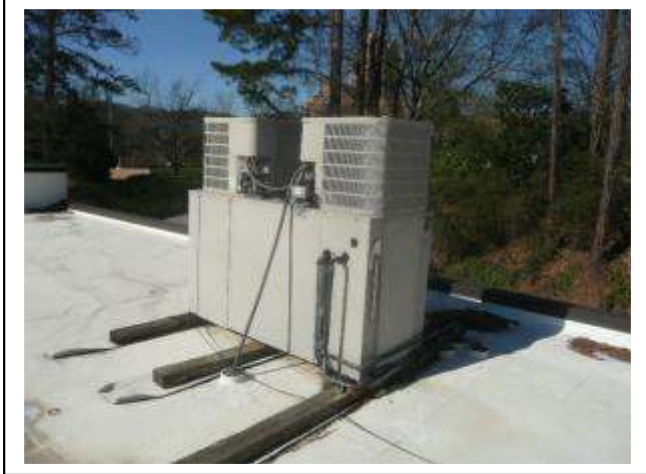
Roof top equipment over the cleaners tenant

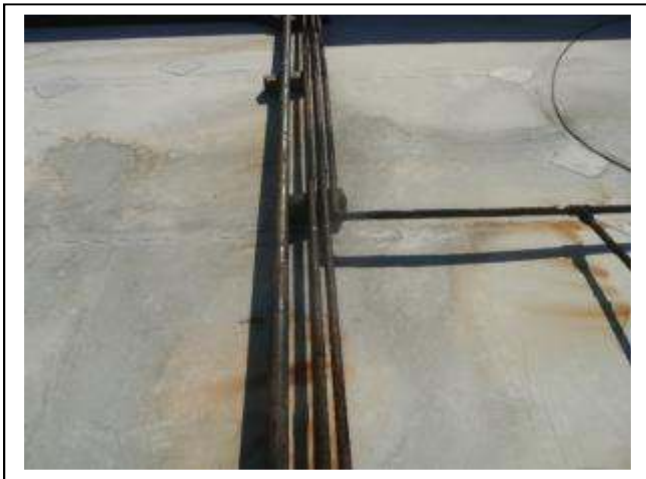
Rusty gas pipes

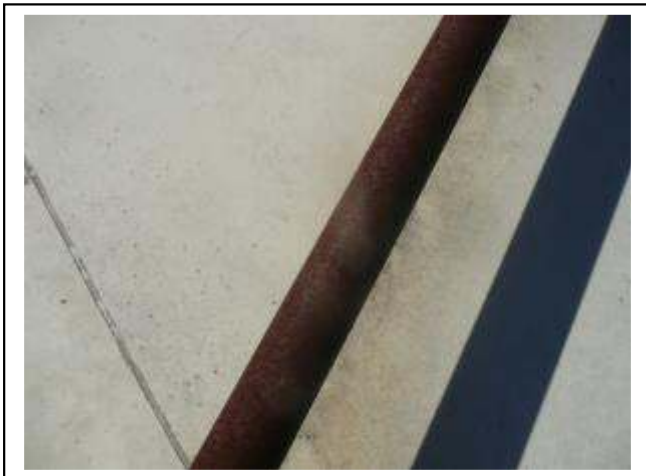
Closer view of rusty gas pipe

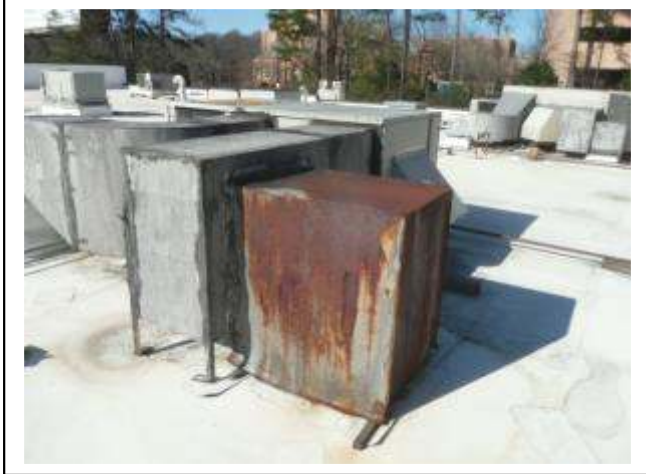
Rusty external HVAC duct work

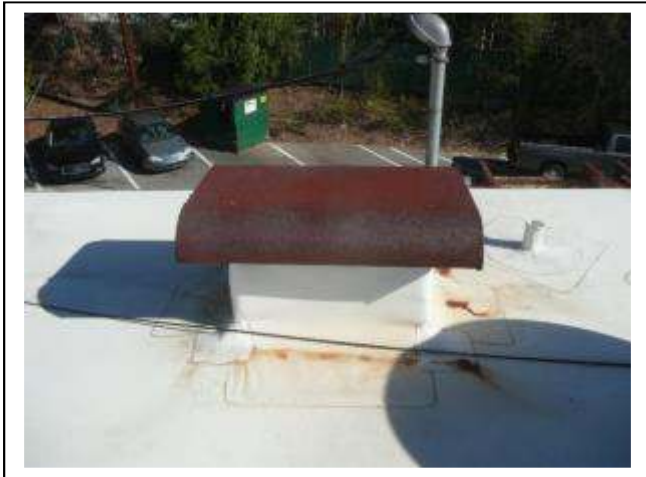
Rusty vent

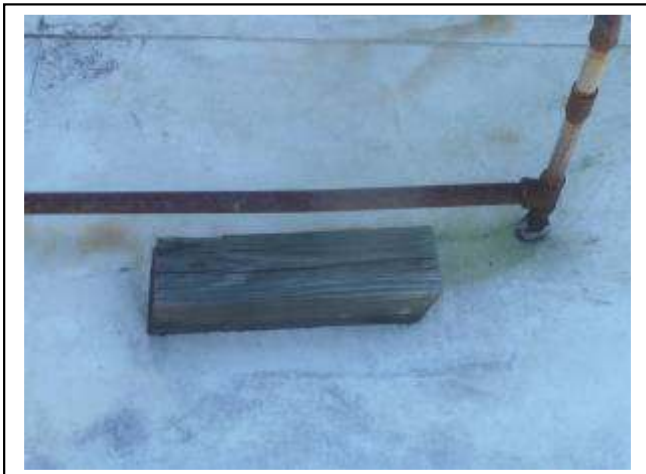
Misplaced gas line support

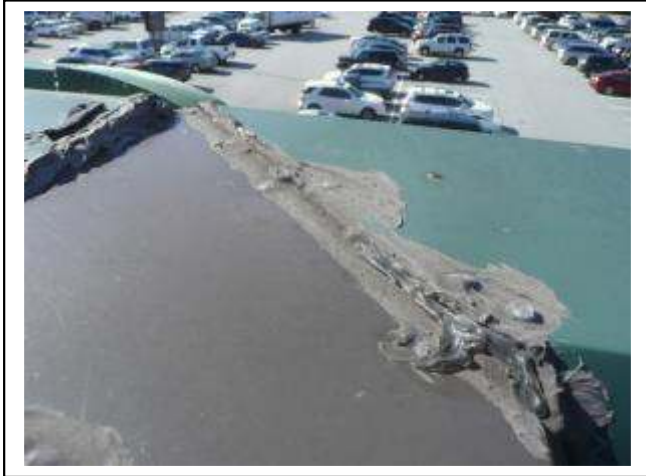
Old/failing sealant on coping metal joint

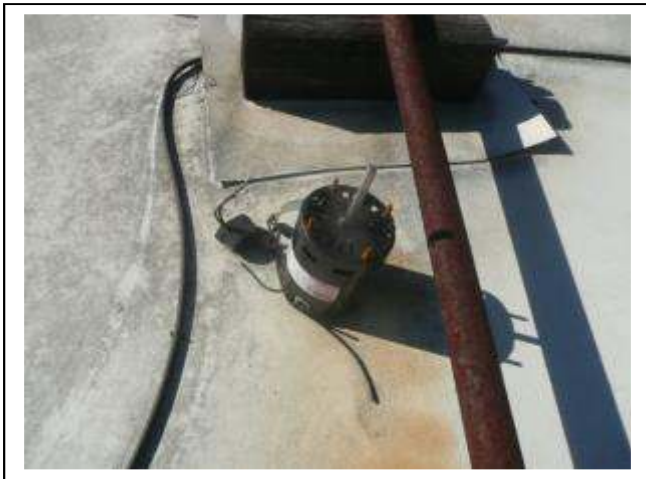
Trash

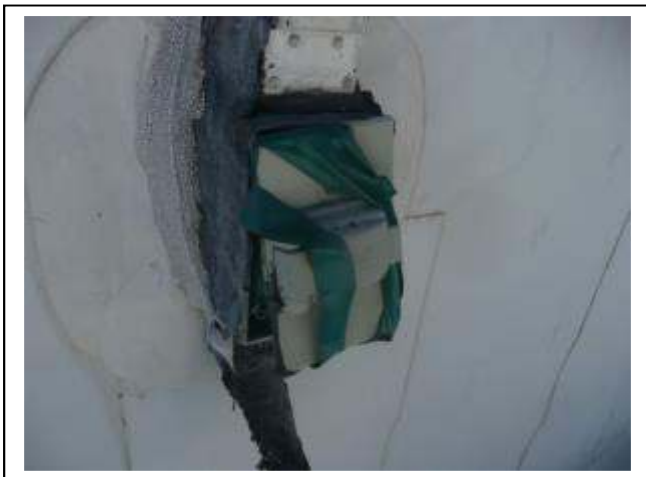
Quality electrical work

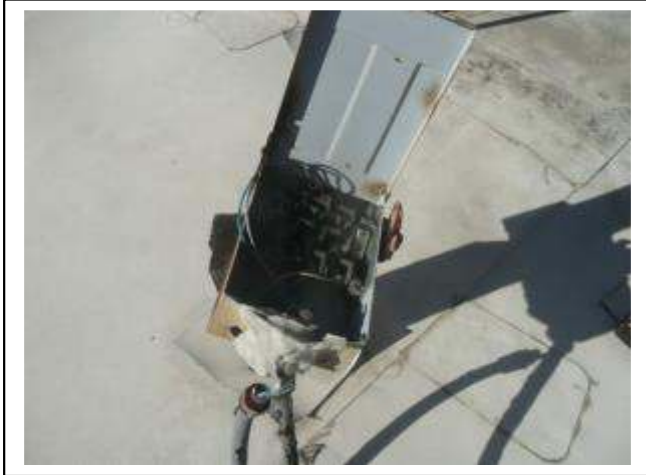
Open/exposed HVAC electrical breaker box

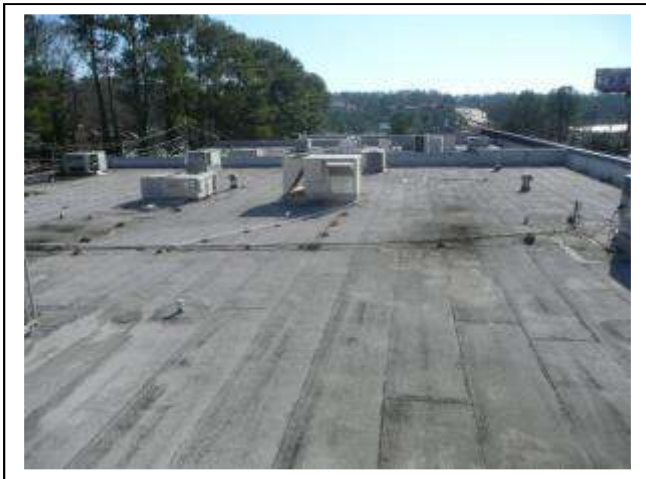
The built-up roofs are in poor condition and have served their useful life. Leaks should be repaired on an "as needed" basis and the roofs should be replaced as soon as possible to avoid catastrophic roof failure. There are almost certainly unreported roof leaks occurring in most of the suites based on what was seen on the roof. The following anomalies exist:

Overview of built-up roof **suites**
9,10,11

- Install a new TPO roof- Estimated Cost \$66,000
- If a new roof is not able to be installed in 2016, you should expect to spend roughly \$10,000-\$15,000 in maintenance and repairs in an effort to extend the life of the roof another year. Even with repairs and maintenance there is no guarantee that the roof will last any longer given its current poor condition.

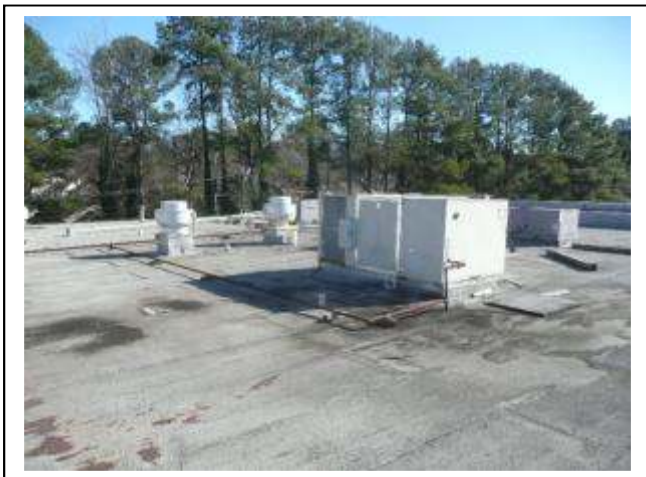
Overview of TPO roof **suites**
12A,12B,13

- Install a new TPO roof- Estimated Cost \$48,000
- If a new roof is not able to be installed in 2016, you should expect to spend roughly \$7,500-\$12,500 in maintenance and repairs in an effort to extend the life of the roof another year. Even with repairs and maintenance there is no guarantee that the roof will last any longer given its current poor condition.

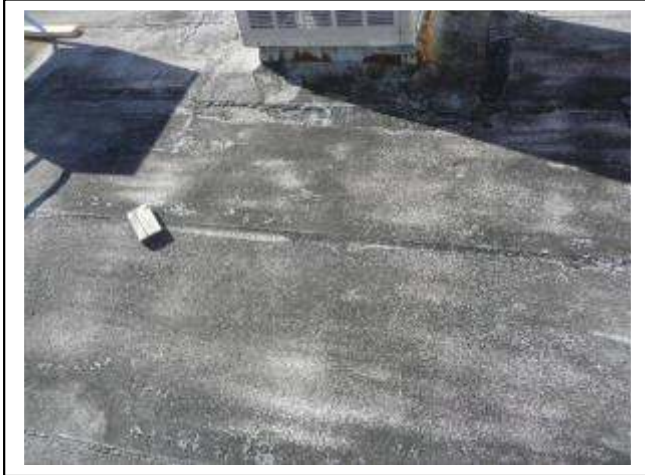
Closer view of the white granular modified cap sheet- most of the granules are missing indicating heavy wear.

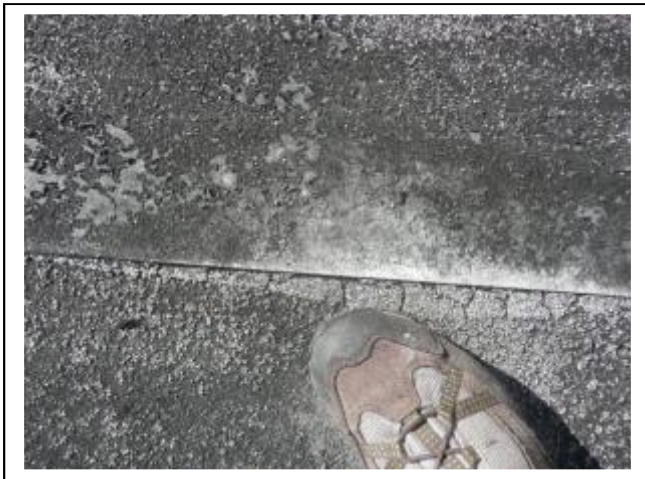
Close up view of the modified cap sheet. The lap is worn thin and it is opening up.

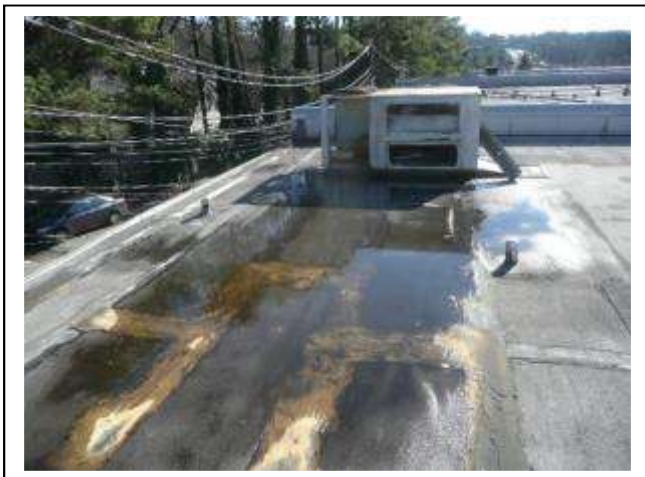
Large area of ponding water

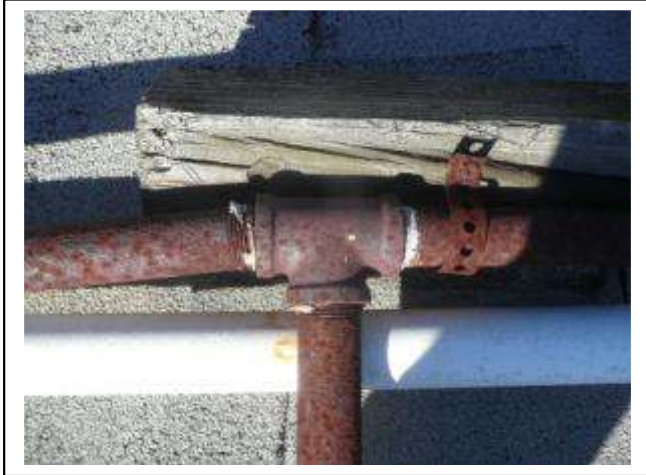
Broken T connection on gas pipe

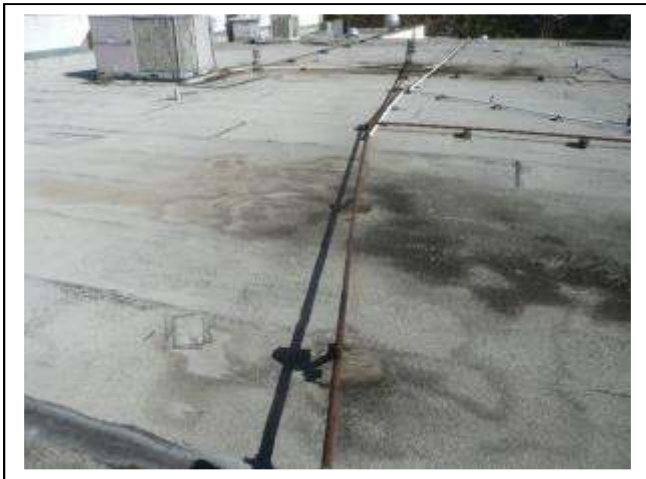
Showing the pipe leading to the broken connection

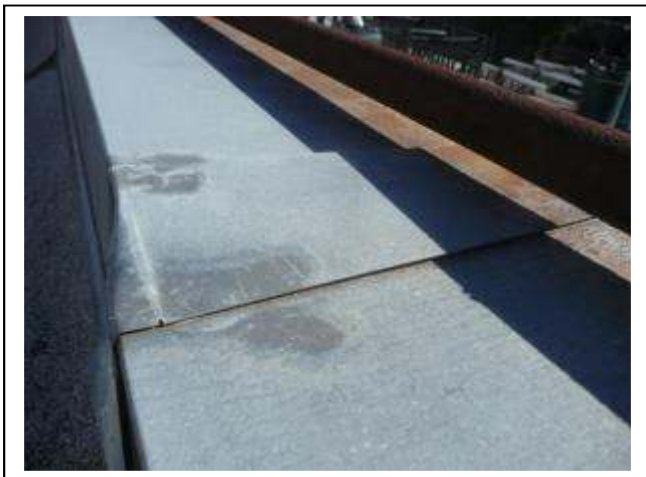
Open coping metal joint

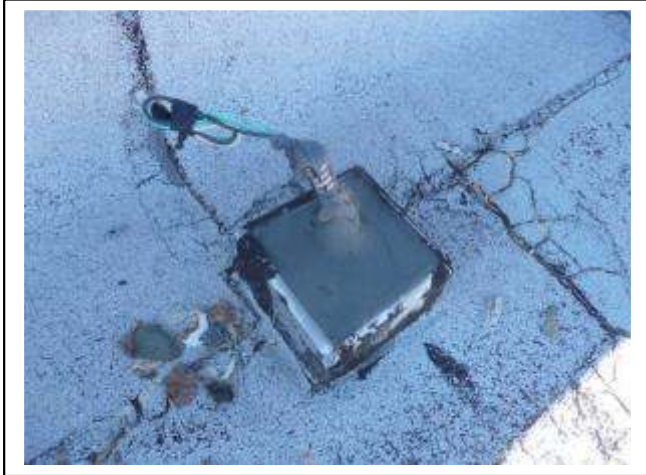
Open pitch pan

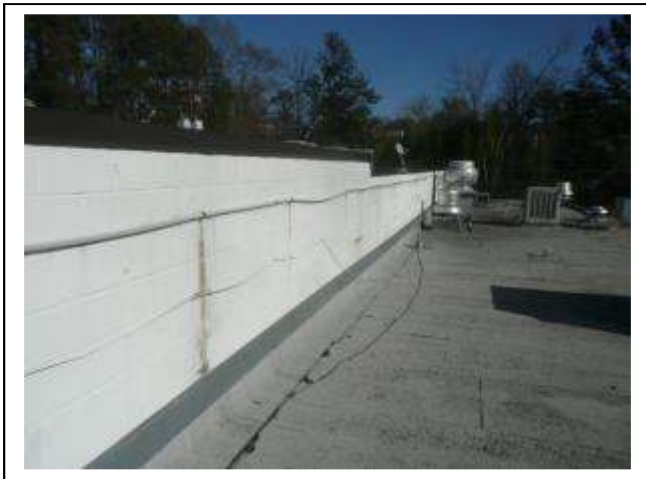
Unprotected parapet wall- peeling and unmaintained paint. The wall should be covered with TPO during the reroof process

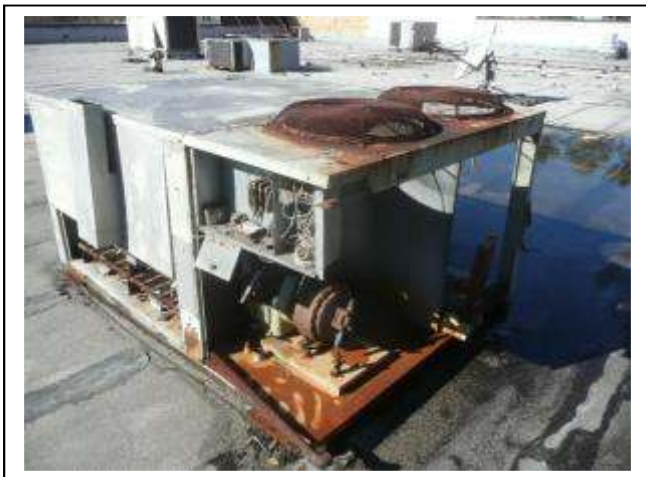
Abandoned equipment.

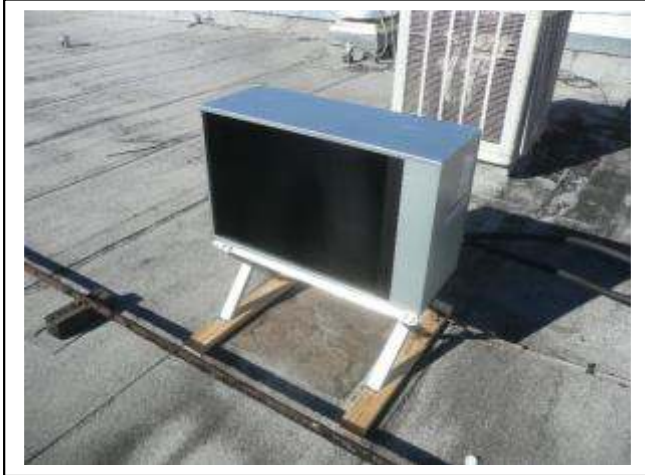
Missing protective pads under tenant installed equipment. The equipment is also not properly secured.

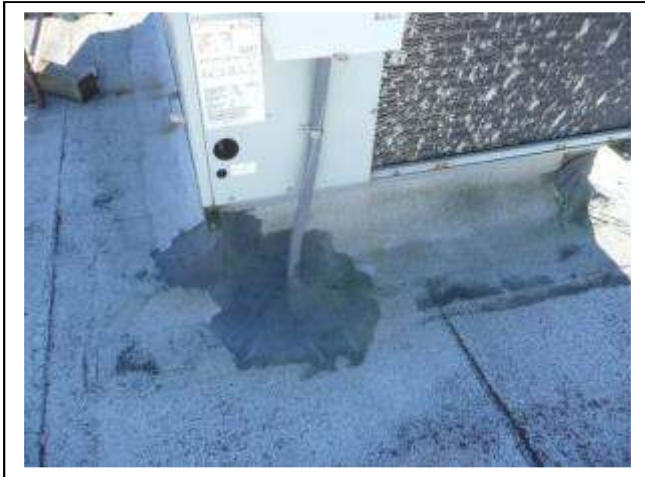
A few different electrical conduits were installed through the roof too close to the HVAC units. They are not able to be properly flashed.

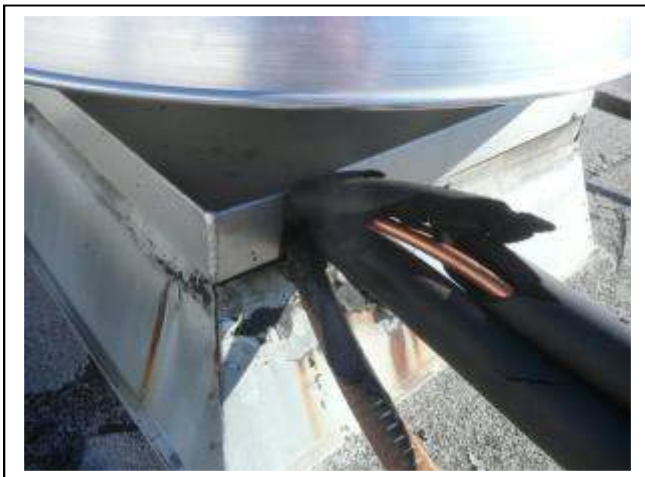
This line set was incorrectly installed through the side of a fan curb. It is not able to be properly flashed..

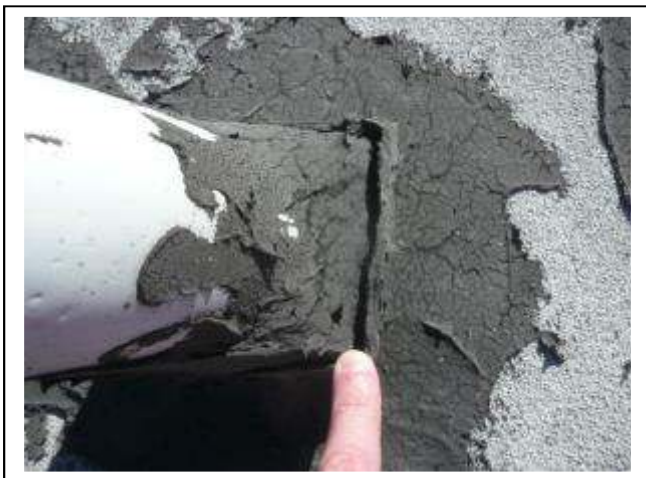
Unflashed penetration

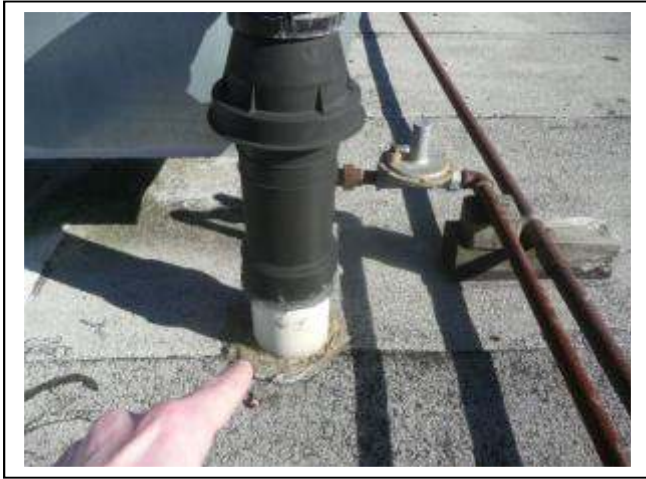
Closer view of unflashed penetration

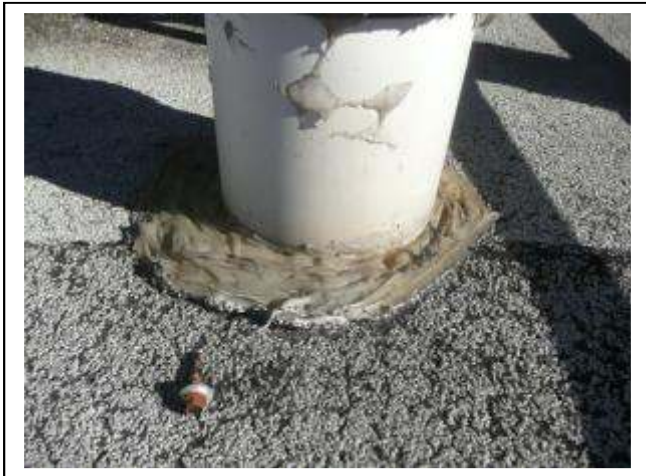
This metal gas line support does not have a pad under it. The support has been pushed into the roof.

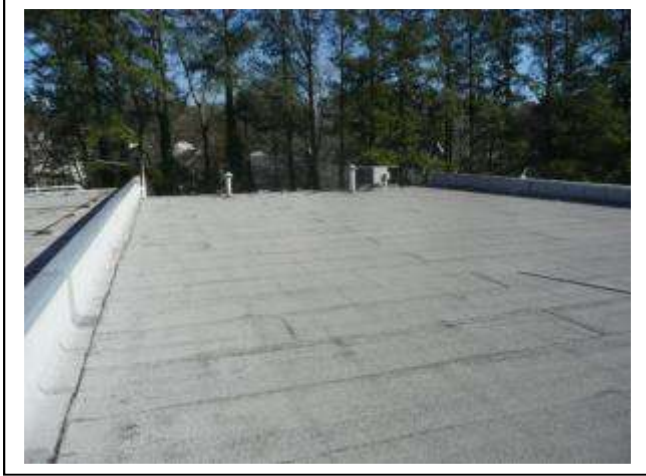
The built up roof is not as bad as the previously reviewed sections 9-13 although there are a lot more large blisters on the surface of the roof over suite 14 which may indicate that moisture is trapped under the roof. With routine maintenance and repairs, you may be able to get another 1-3 years out of the roof. There are a lot fewer roof penetrations on this section and it looks to have had a lot less foot traffic over the years. The roof top HVAC units are a little newer than on the other sections. The following anomalies exist:

Overview of built-up roof **suite 14**

- This roof may benefit from roof maintenance but given the large blisters and likely trapped moisture, it may make the most financial sense to replace this roof at the same time as the above two sections. Estimated Cost for a new TPO roof \$25,000
- If a new roof is not installed, the following roof maintenance items are recommended at an estimated cost of \$3,500
 - Cut all blisters to allow the air and moisture to escape
 - Press all blisters as flat as possible
 - Properly patch the cut area of roof over each blister
 - Fill all pitch pans
 - Seal all storm collars

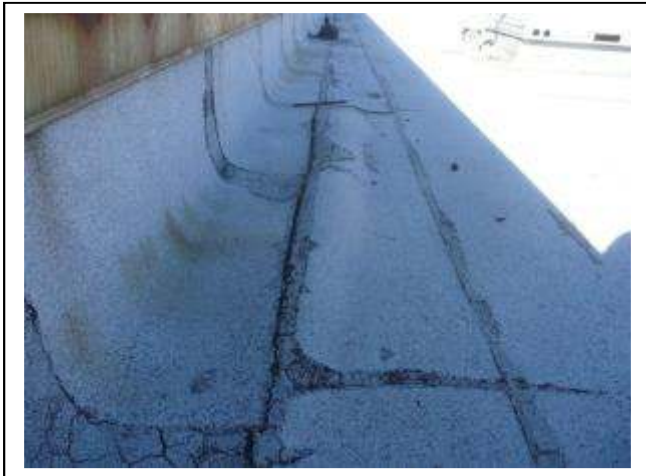
Large blister

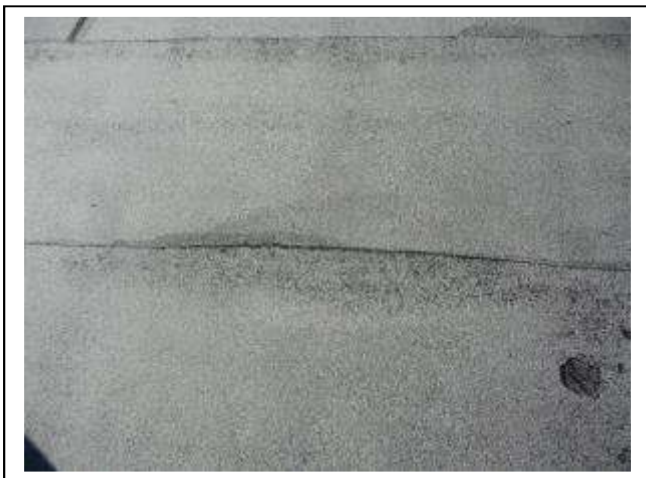
Large blister.

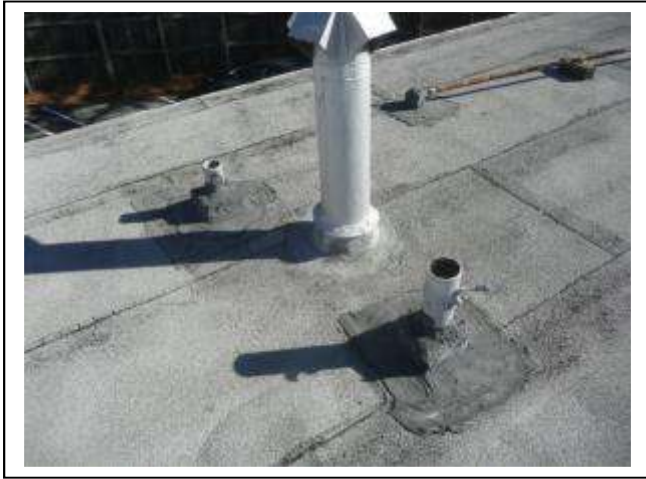
Open pitch pan

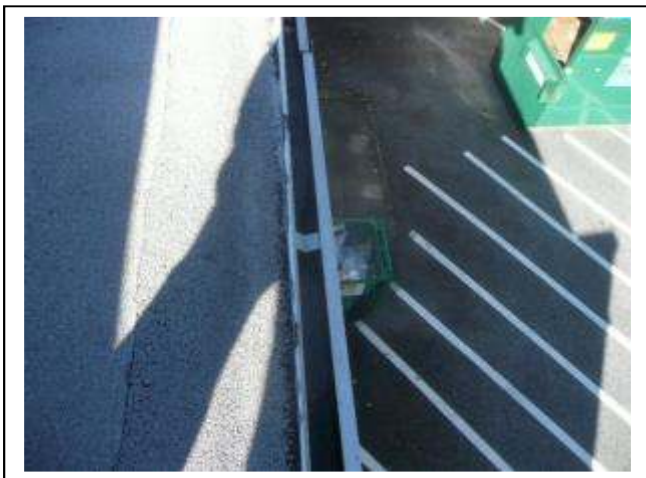
This built-up roof is in better condition than all previously reviewed built-up roofs at this shopping center. With routine maintenance and repairs you may be able to get another 3-5 years out of the roof. The following anomalies exist:

Overview of built-up roof **suites 18, 19,22**

- Estimated cost for the following 3 items: \$950
- Insect all penetration flashings and repair open areas as needed
- Seal all vent pipe storm collars
- Monitor wall flashings

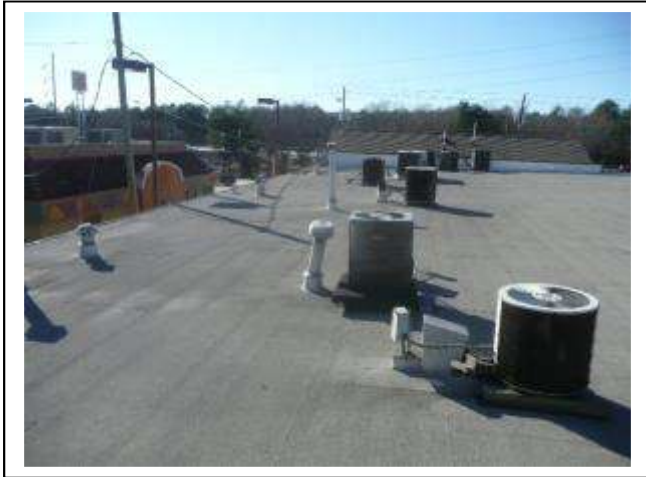
Abandoned equipment

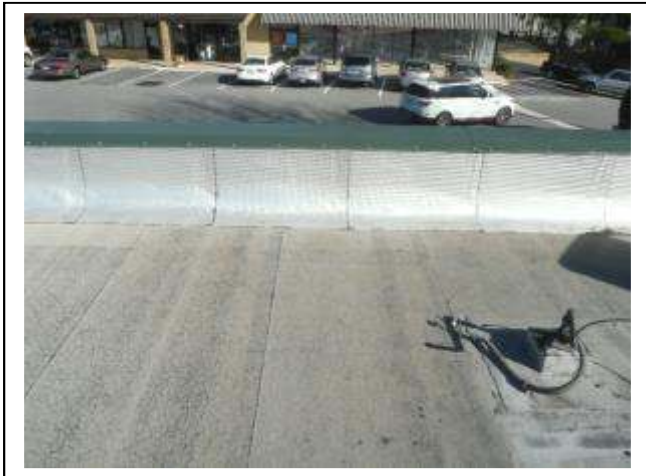
There is some minor delamination occurring on the wall flashing
